Technical Bulletin #9

# NATIONAL SLATE ASSOCIATION

## Technical Bulletin No. 9: Common Myths About Slate Roofing

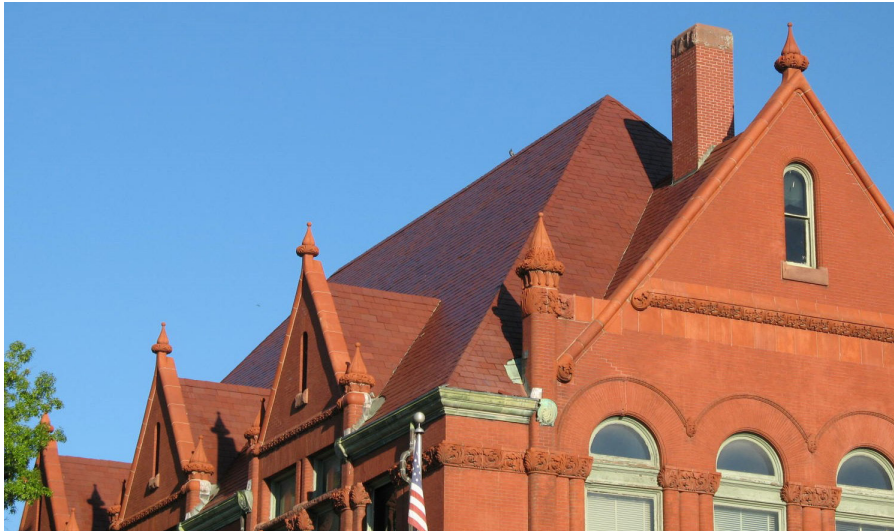
Figure 1: 120-year old New York red slate roof in Lawrence, Kansas

The service life of slate shingles depends largely on the geology of the slate - its mineral composition and the heat and pressure it was subjected to during its formation - a process known as metamorphism. Using past history as a guide, it is known that different roofing slates have different expected service lives depending on the geographic region from which they derive (Figure 1). These expected service lives, assuming all other things associated with the roofs on which the shingles are installed are equal, can be summarized as shown in Table 1.<sup>1</sup>

Of course, all other things are never equal, and factors such as roof slope and orientation, the presence of shade trees, runoff from low-slope roof areas located above the slate, geographic location of the installation, foot traffic, the quality of the original installation, and maintenance activities, all impact the longevity of the roof system. As such,

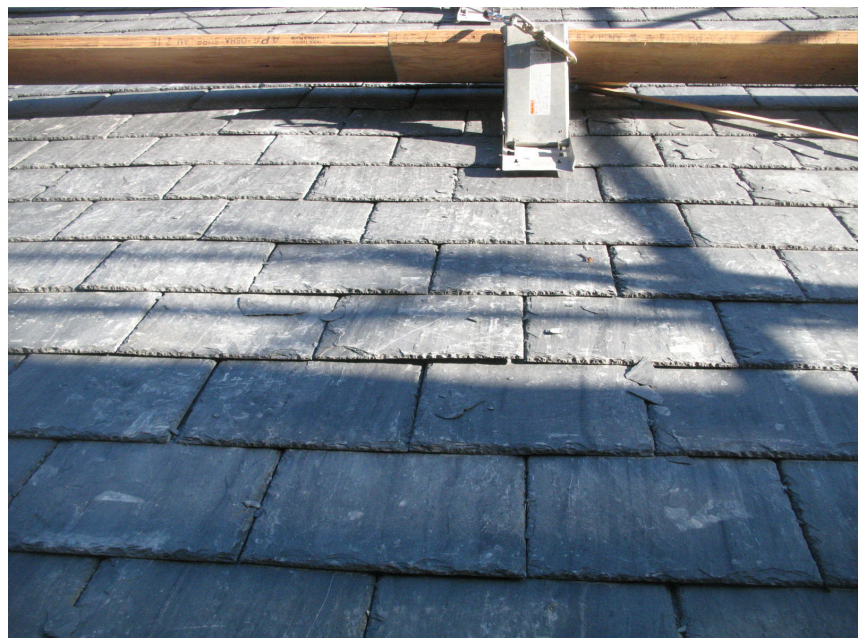
Figure 2: Slate fines and fragments present on the roof prior to the final sweeping-down. Some of these will invariably remain on the roof and gradually get washed down into the gutters with each passing rain.

installation. Slate fines result from trimming, cutting, and nail punching operations that occur during fabrication at the quarry and during installation on the roof (Figure 2). The slate fines cling to the surface of the slates, and some will remain no matter how well the slates are swept as the means of temporary roof access (typically brackets and planks) is broken down and removed from the roof at the end of the slating process. Fines remaining on the roof after completion will gradually be washed downslope and into the gutters with each passing rainfall.<sup>3</sup> This is typical of all slate roofs, regardless of slate type and is not an indicator of slate quality or durability.

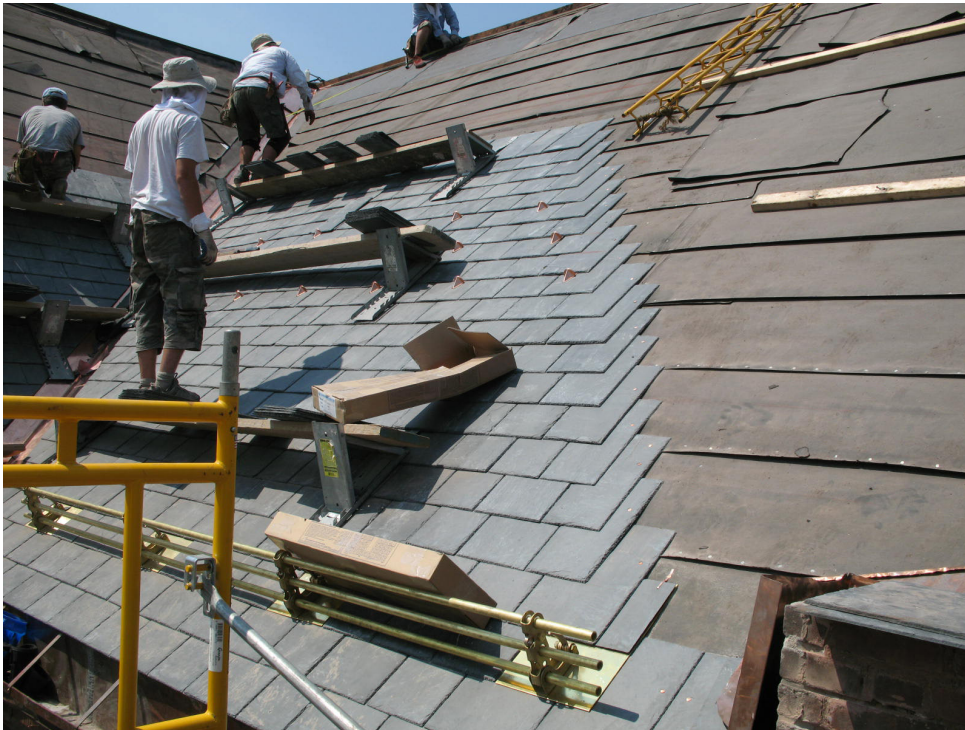
Figure 3: Slate roof installation in progress.
